INSPECTION CONDITIONS

2626 N. XXXX Pl.

Accuspect

Home Inspection Services, Inc.

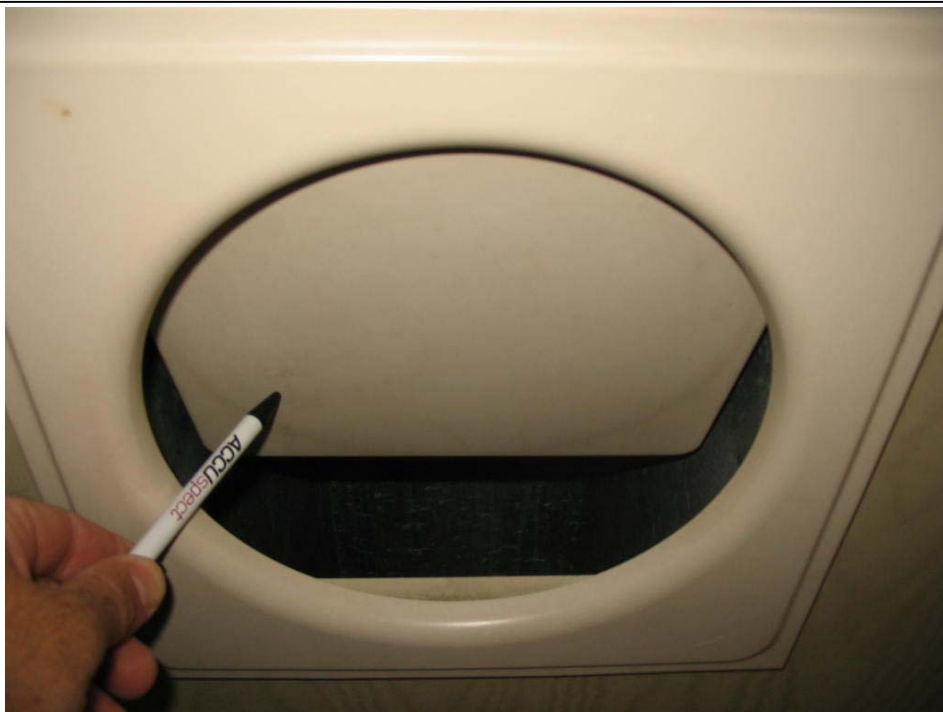
PICTURES 1:

There is a laundry chute present. For child safety reasons, recommend screwing closed the chute to prevent children from falling into the chute.

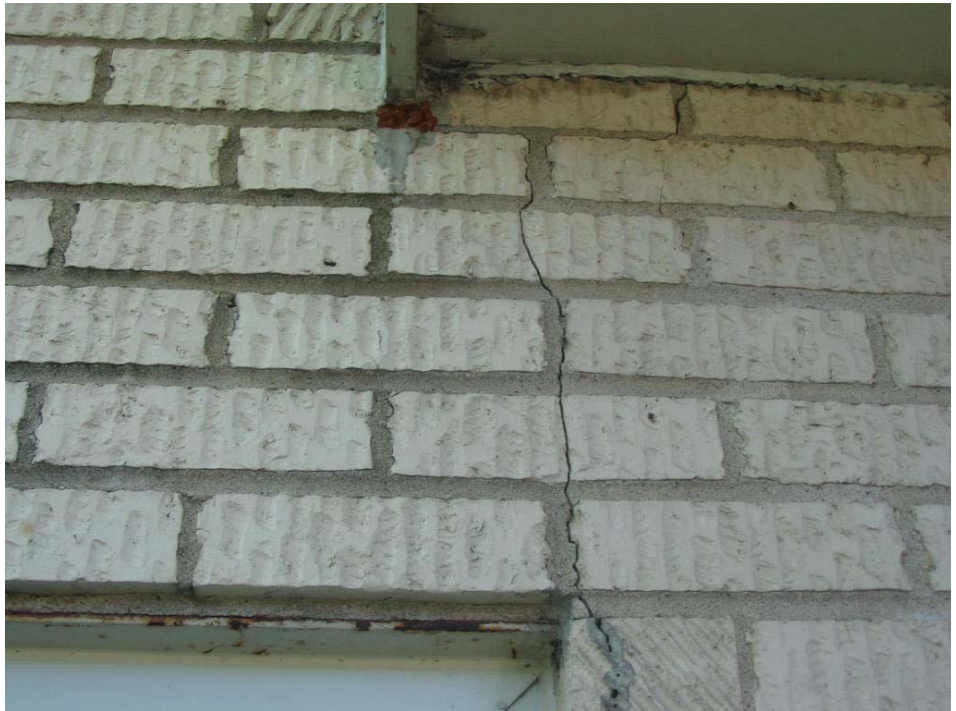
CONDITION 1:

There was vertical cracks noted above, and at the ends of some of the lentals. The lentals may need to be rebuilt. Recommend further evaluation/repair by a licensed massonary contractor.

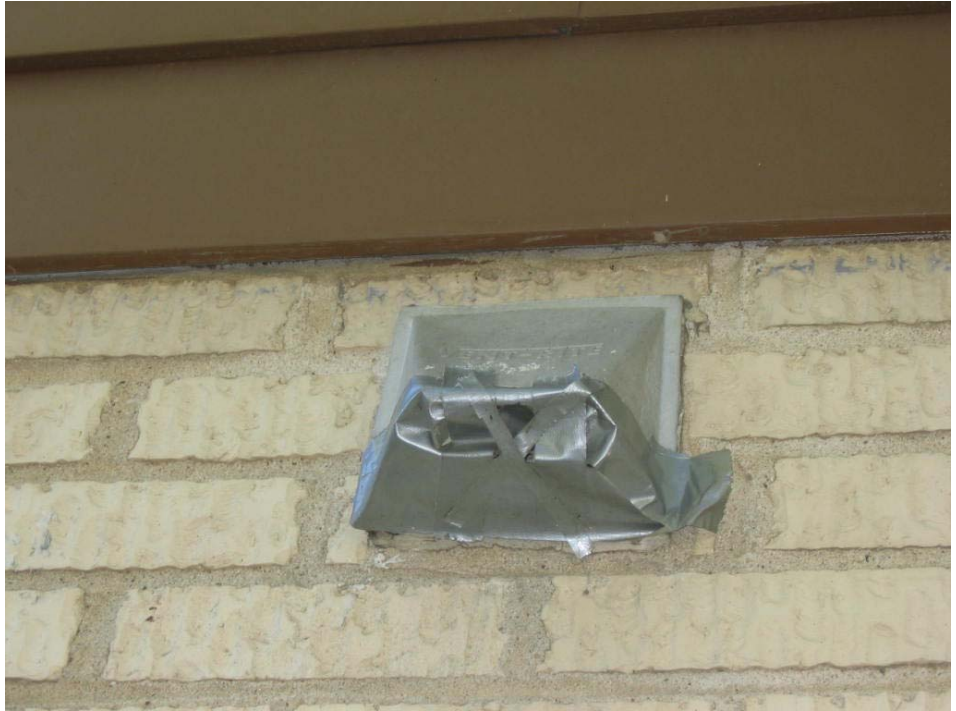
A rear vent was taped up. Repair/replace as necessary.

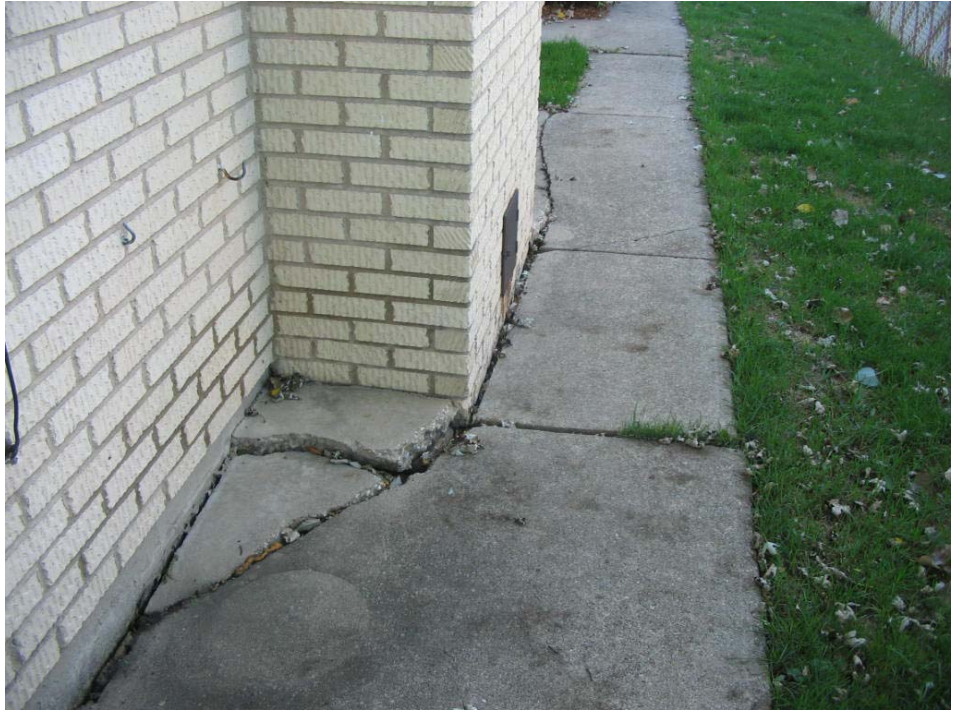
Cracks noted are major. Repair/replace effected sections. The walks are sloped toward the house, this may allow for water to be diverted into the foundation. Monitor the condition, and if needed raise/replace effected sections of walk.

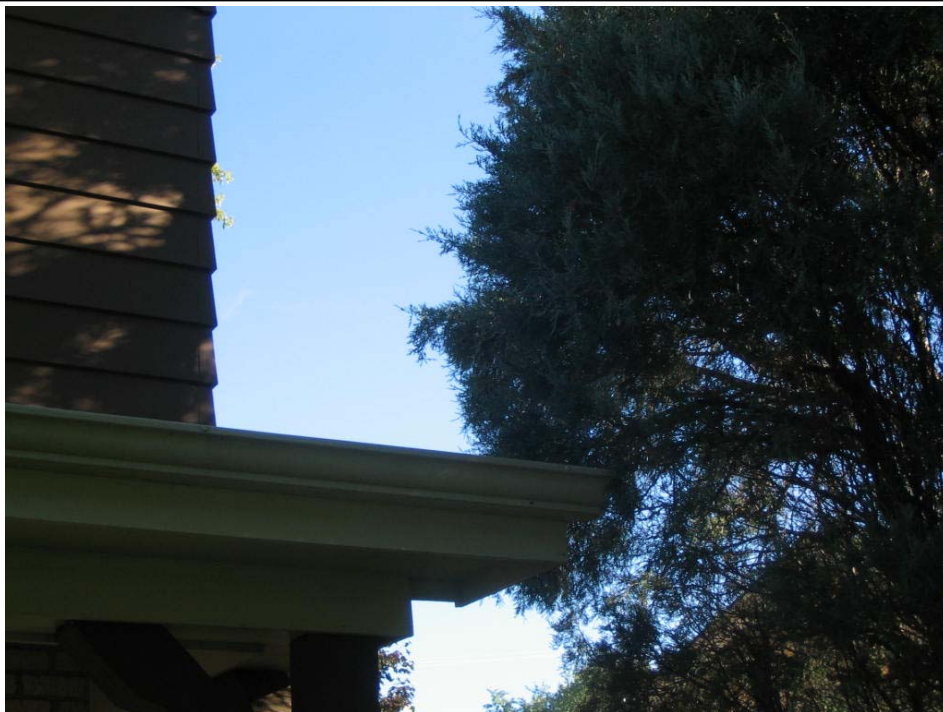
Trees are touching or overhanging the roof. Damage is possible, trim back effected sections of the tree.

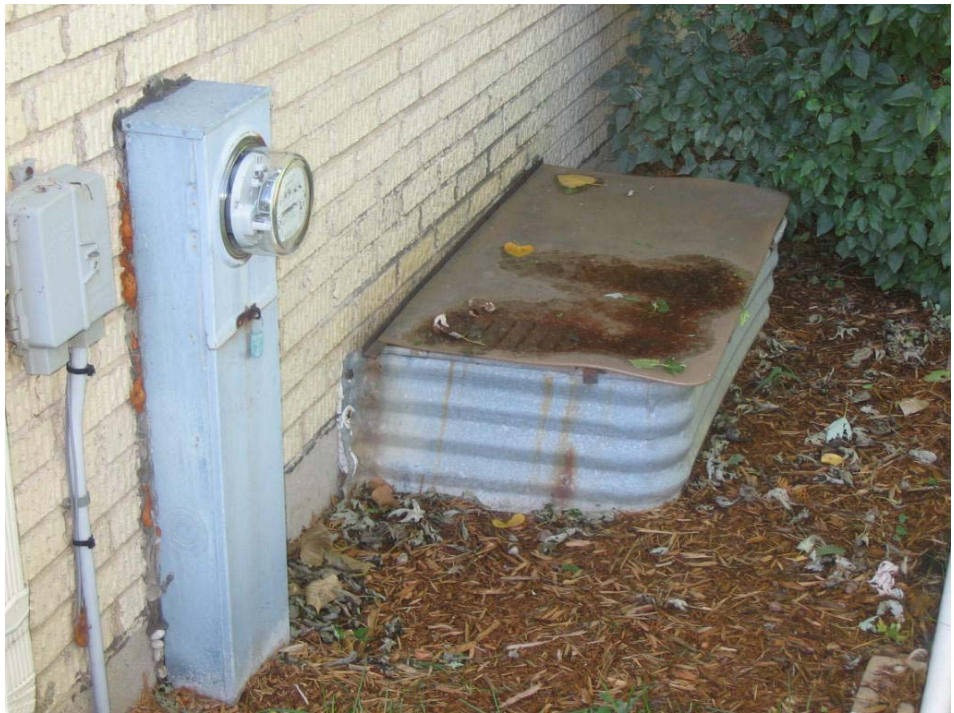
Pitch slope of soils away from foundation. Slope should fall away from the foundation at a minimum of 1/2 inch per foot and extend at least 10 feet away from the foundation.

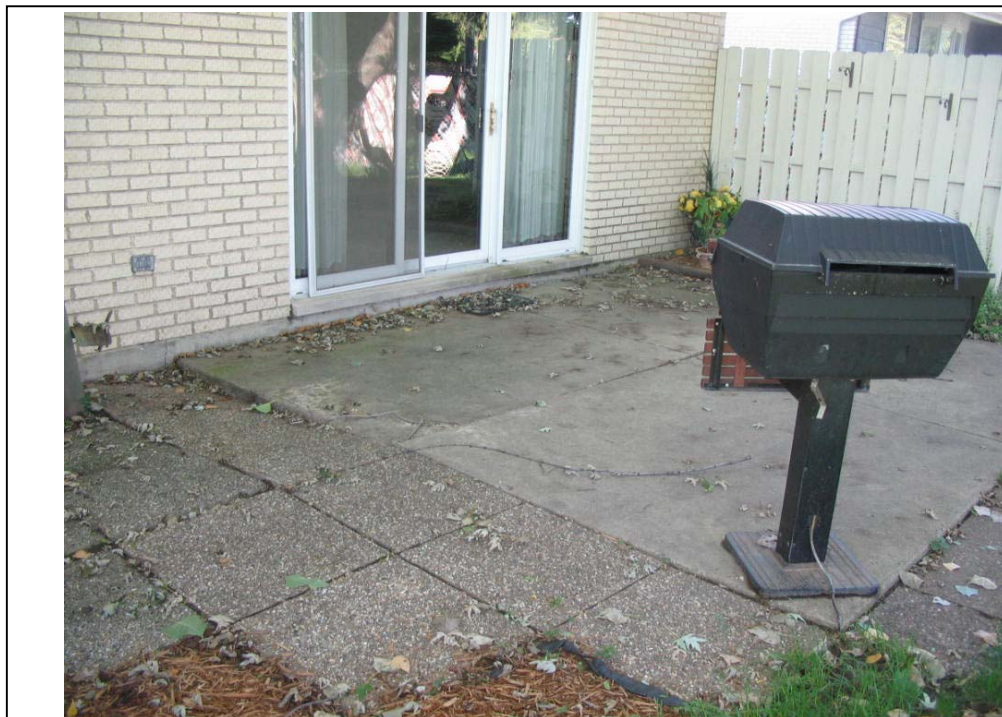
Cracks noted are major. Repair/replace effected areas. The patio is sloped towards the building. This can lead to water diverting into the foundation. Monitor the condition and possibly consider regrading or mudjacking up the patio.

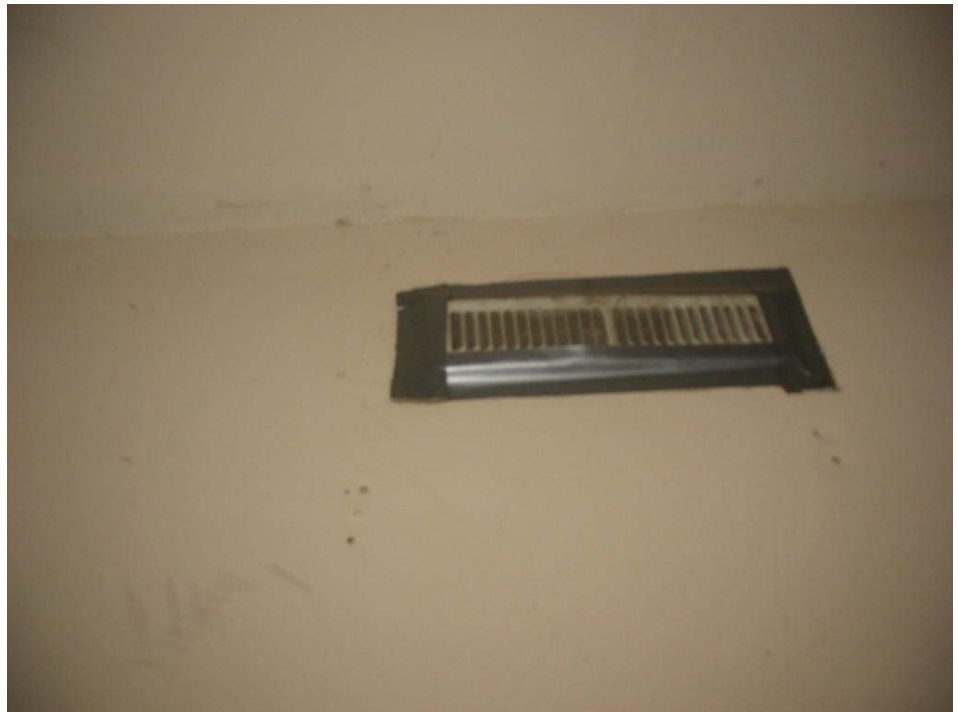
The attic hatch is not made from approved fire rated materials. Install approved fire rated materials over the access door to restore its fire rating. Damage/missing sections to the fire wall is noted. Repair any openings with approved materials to restore its proper fire rating.

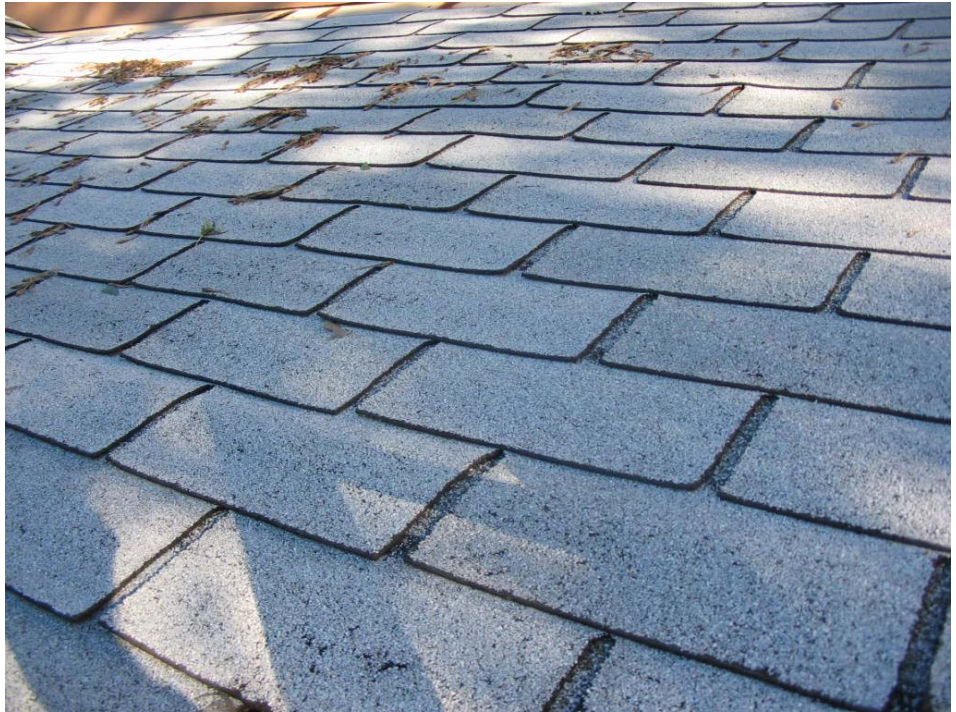
Cracking and clawing of shingles are the result of long term weathering and an advanced shingle age. There was also excessive granular wear noted. The roof appears to have two layers of shingles installed. Anticipate the need to replace the roof covering in the not too distant future.

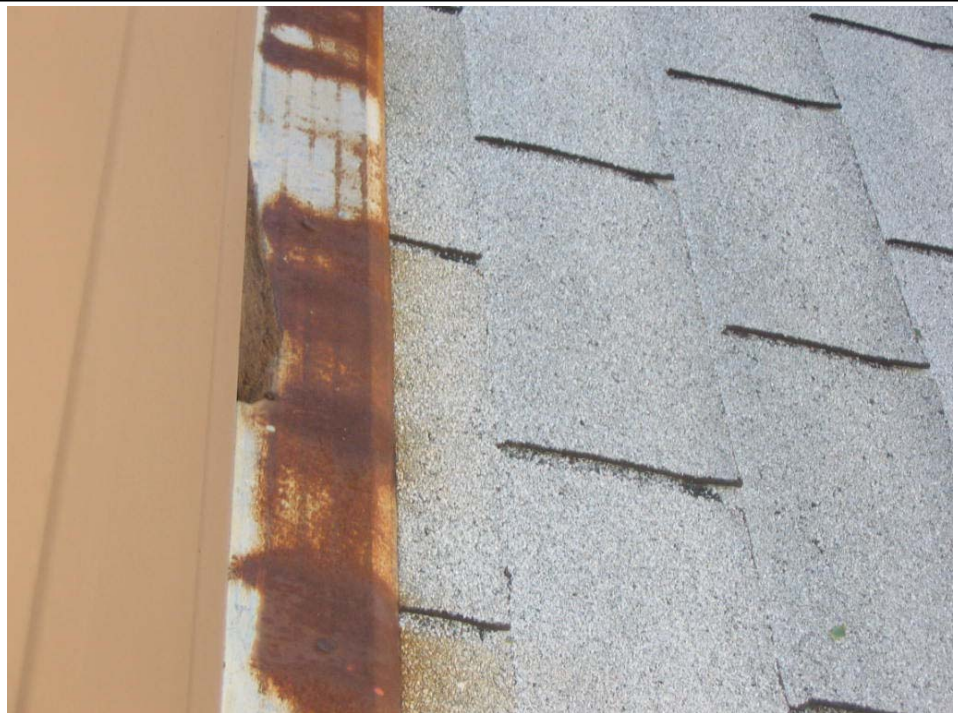
Rusty flashing is noted, monitor conditions, and replace if necessary.

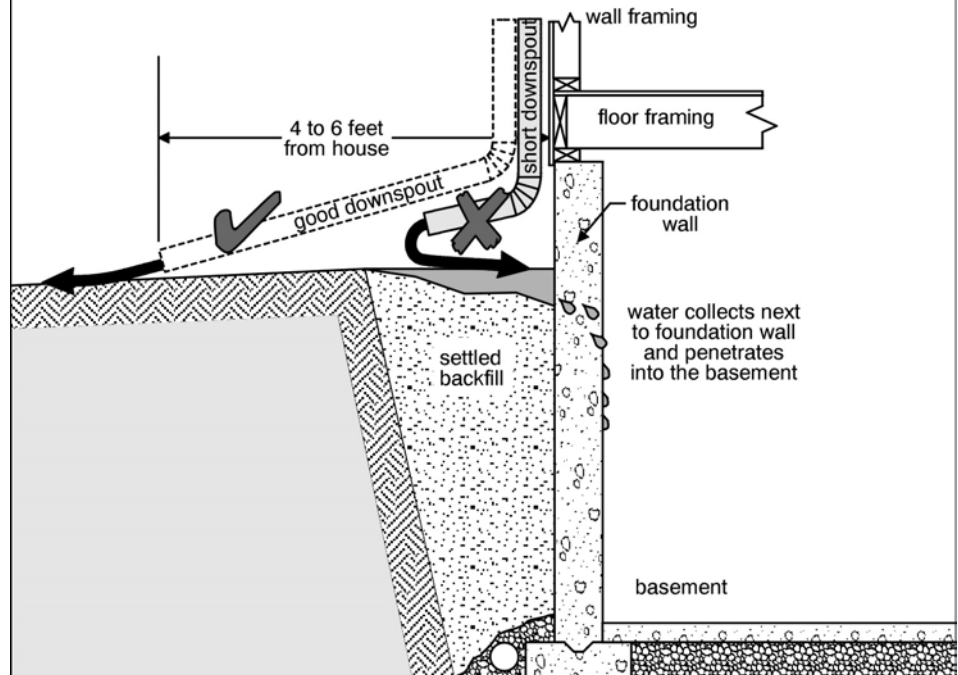
Downspout extension too short

In order to prevent water from rolling back/entering the foundation, add downspout extensions.

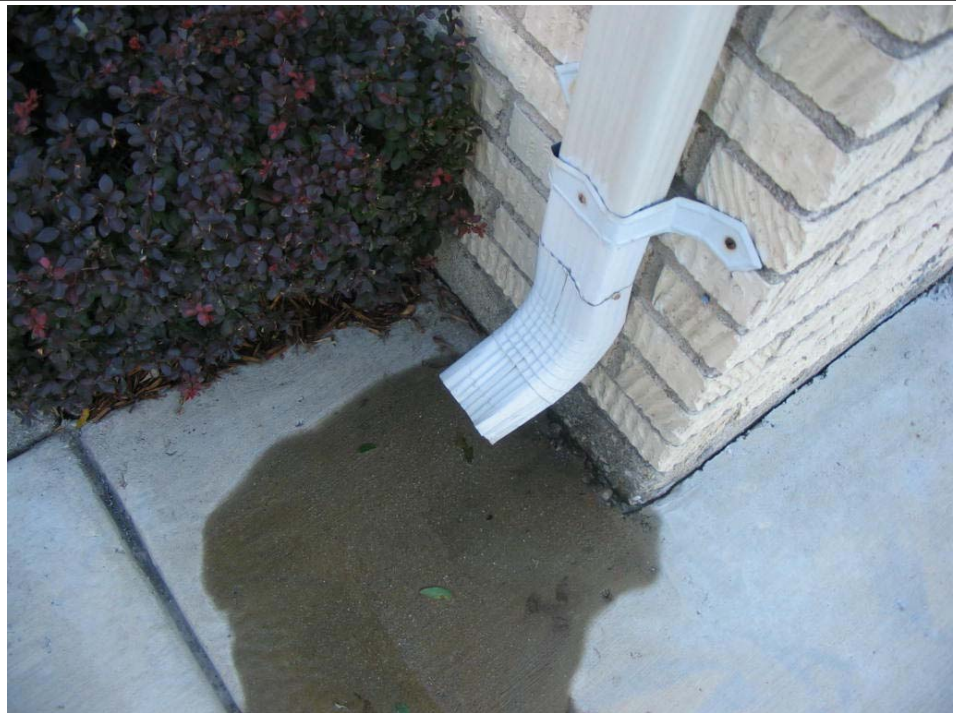
PICTURE A:

This photo shows a downspout that is not extending away from the foundation.

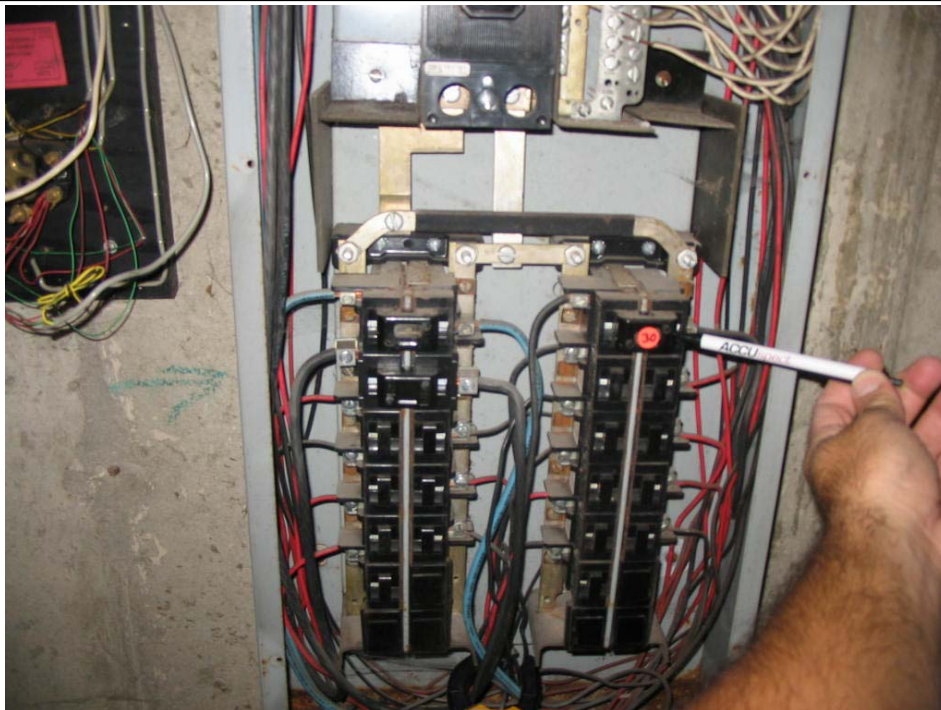
PICTURE A:

BRANCH CIRCUIT PANEL- OVERSIZED CIRCUIT BREAKER: Circuit breakers served by undersized wires are considered a fire hazard, as the wires represent the weak link in the circuit. In this case the circuit breaker(s) should be exchanged for others which are sized appropriately for the wires which serve them. This work, while straightforward, should nevertheless be performed by a licensed electrician. Recommend further evaluation/repair by a licensed electrician. There is one #10 wire going to a 40 Amp breaker. Replace the breaker with a 30 Amp breaker. (if the circuit appliance is rated for 30 Amps or less.)

Replace the marked breaker(s)

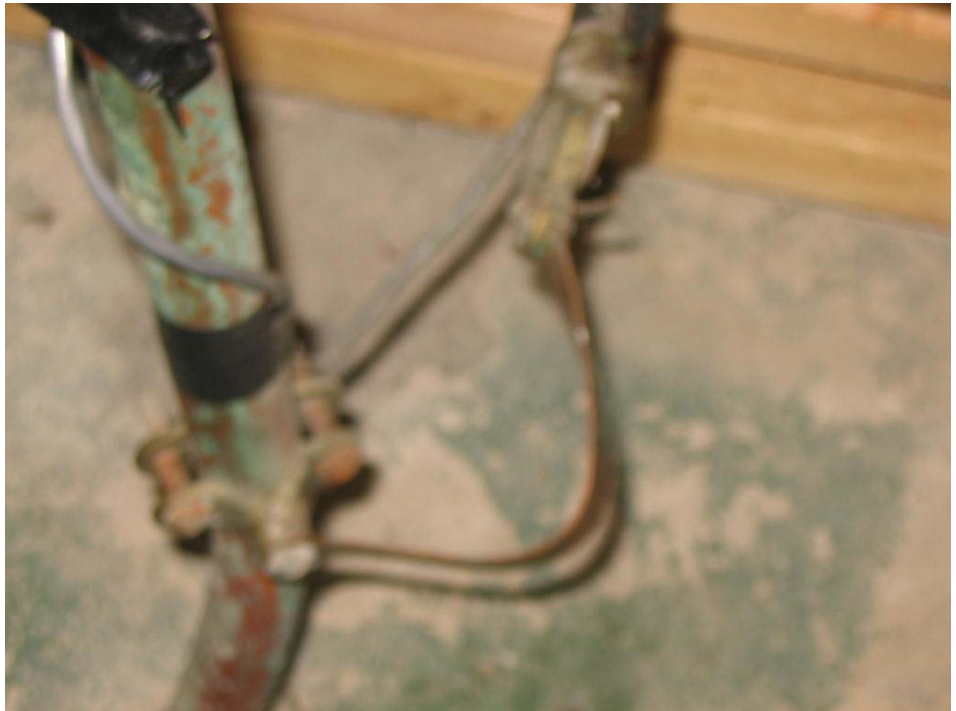
There was no Do Not Remove tag noted to the grounding connector. Install as necessary.

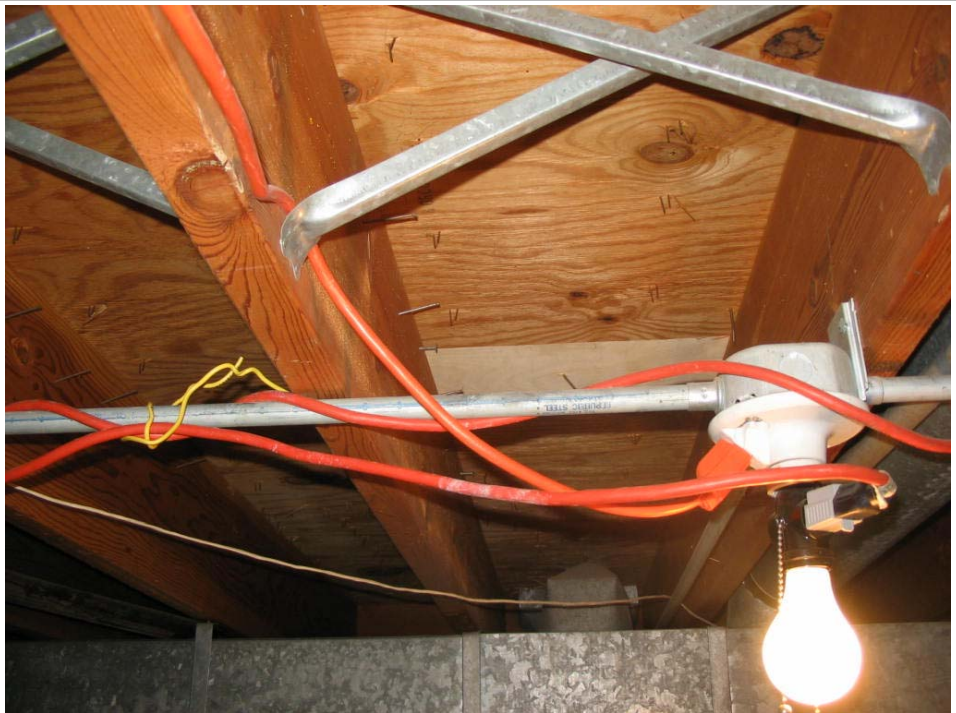
EXTENSION CORD WIRING IS PERMANENTLY MOUNTED: The presence of handyman wiring is an undesirable condition which should be corrected by a licensed electrician. Zip cord or extension cord wiring is not sufficient for permanent installation, as the insulation on the wiring is not formulated for long term use. Over time it deteriorates, eventually causing a fire hazard to develop. Extension cord wiring should be replaced with standard Romex wiring, intended for long term permanent use. Oftentimes, extension cord wiring is also undersized, in relation to the loads imposed on it. A licensed electrician should be called in to rewire any appliances connected by the use of extension cord wiring.
Noted to the basement shop lights.

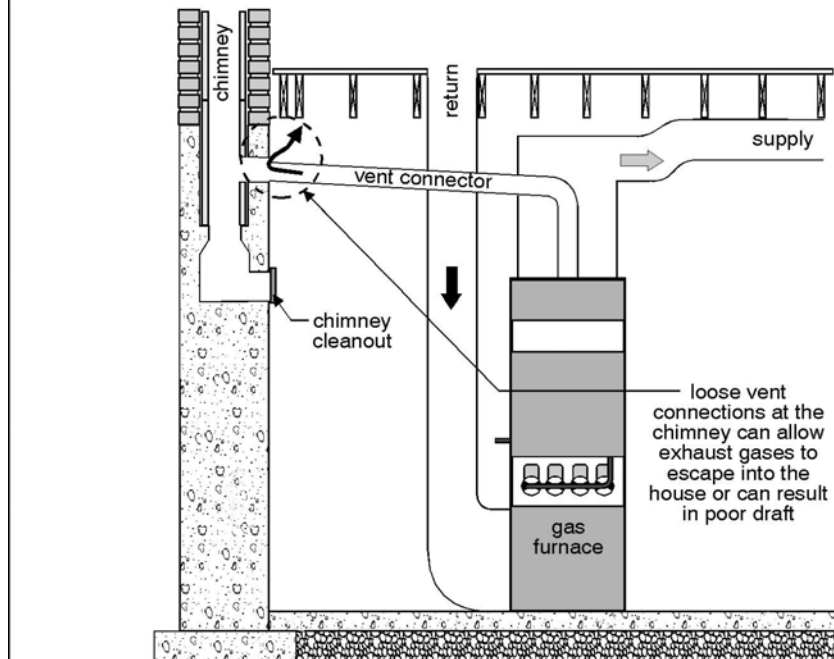
Vent connector loose at chimney

The vent/chimney junction is deteriorating. This could possible allow for carbon monoxide to enter the home. Properly seal up this junction with furnace cement.

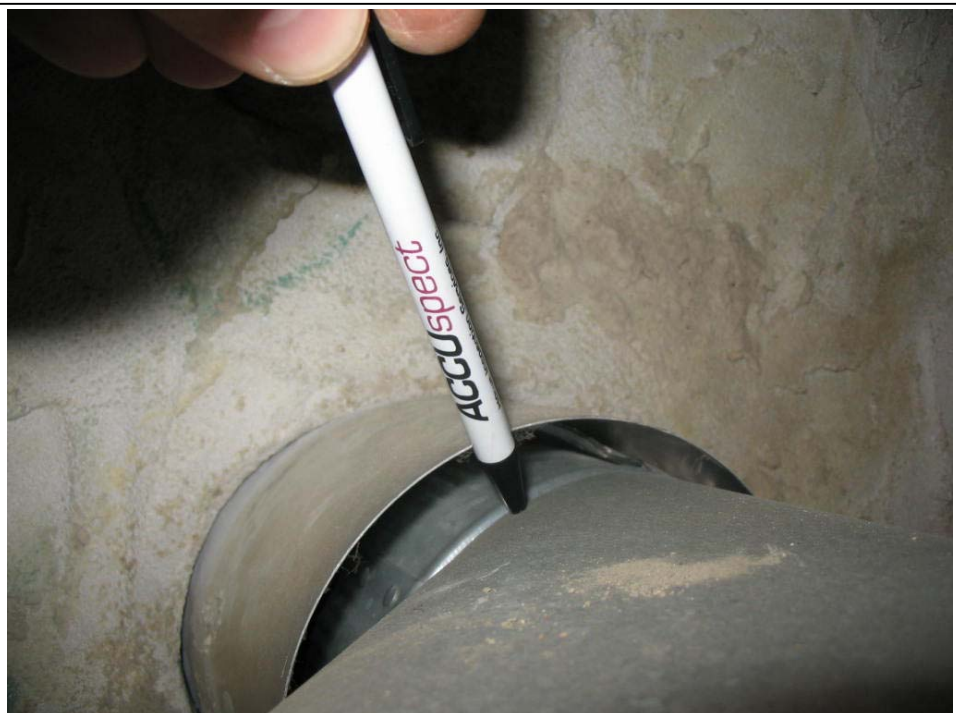
PICTURE B:

This photo shows the deterioration in the vent/chimney junction.

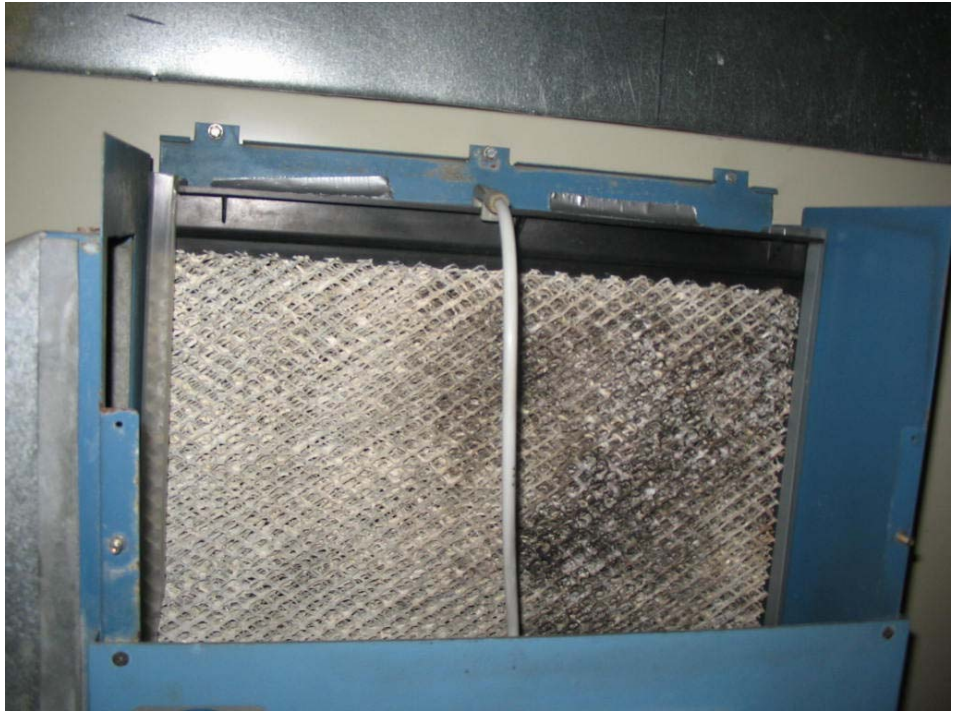
The humidifier pad is dirty. Clean the unit, and replace pad.

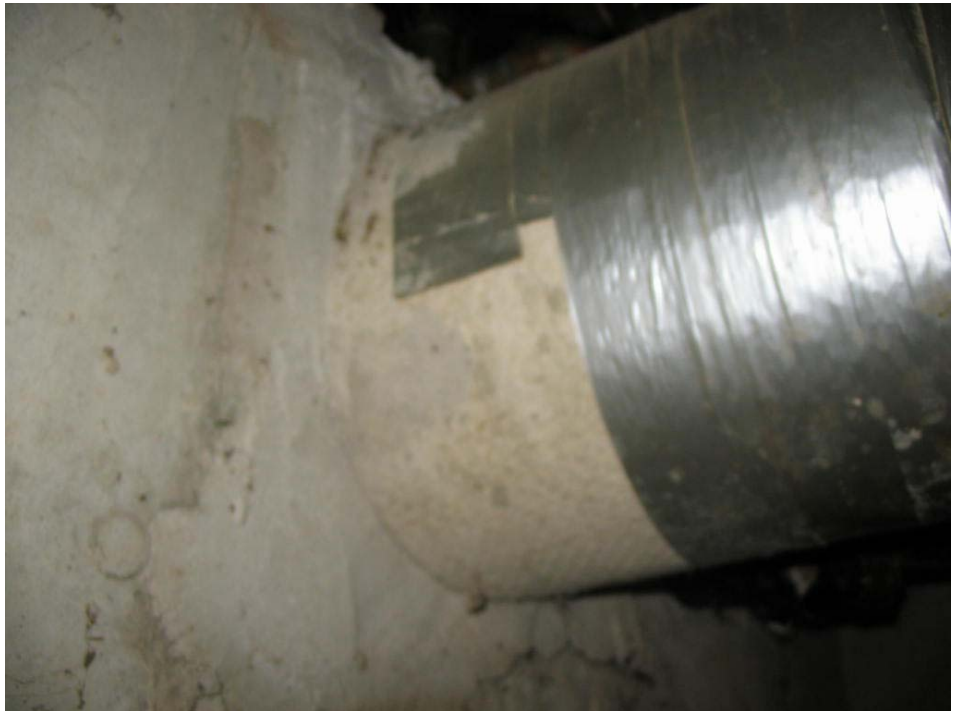
There is white material on/in some of the heating ducts/vent pipes. It is possible that this may contain asbestos. Unable to determine without laboratory analysis. Recommend further evaluation by a specialist.

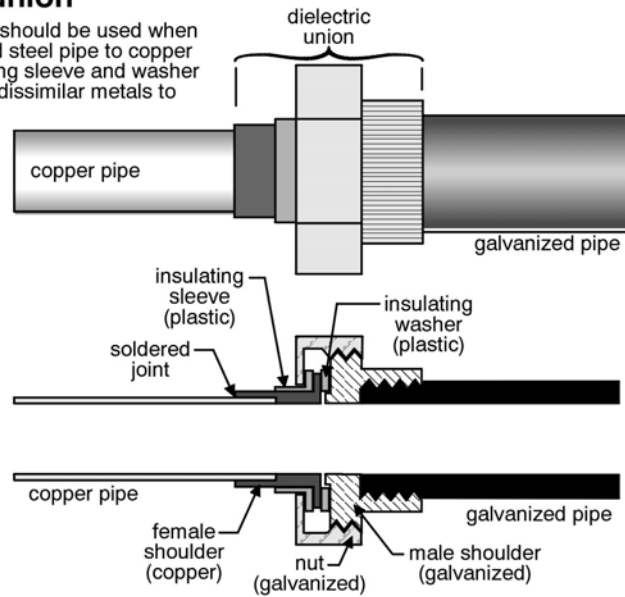
There is galvanized and copper piping joined together. These two dissimilar metals when joined will cause corrosion, (as may be noted). Properly install dielectric union on the cold water side to insulate the pipes from each other.

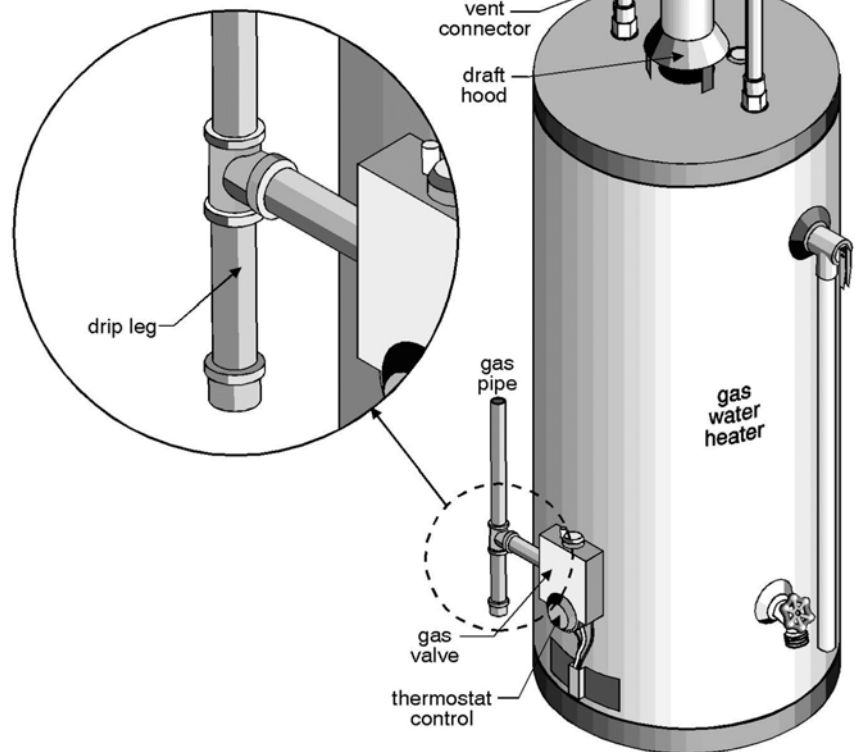
The gas line was loose/not properly secured. Properly fasten the gas line. There is a flexible gas connector supplying the unit. Remove the flex line and properly install a hard gas line. There is no drip leg installed. A drip leg catches moisture and dirt before its gets a chance to enter the gas valve and plug it up. It is recommended to properly install a drip leg.

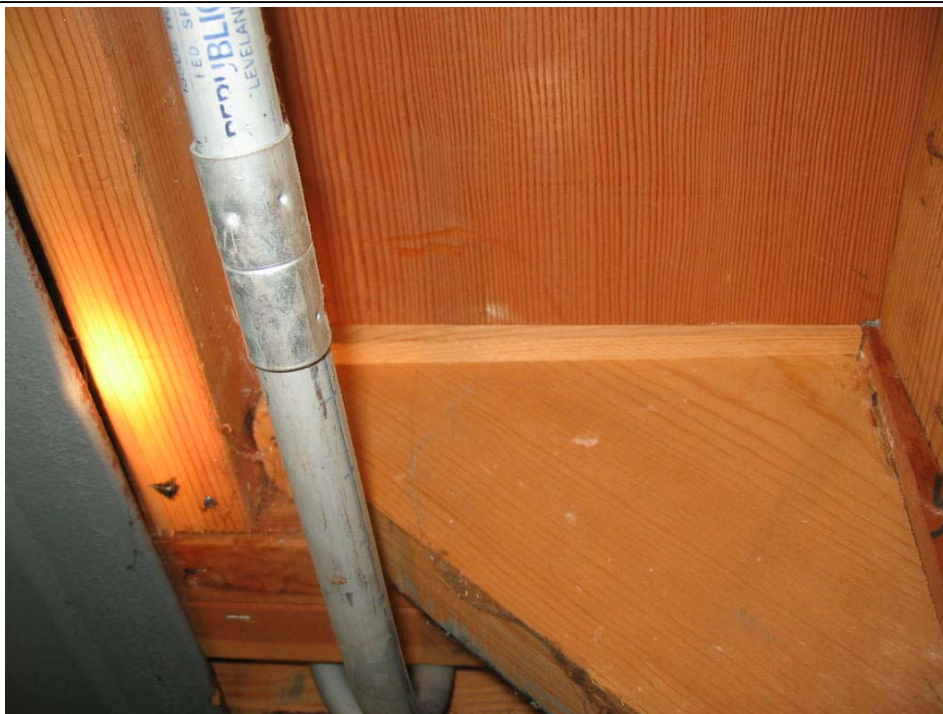
The staircase is improperly secured. Repair as necessary.

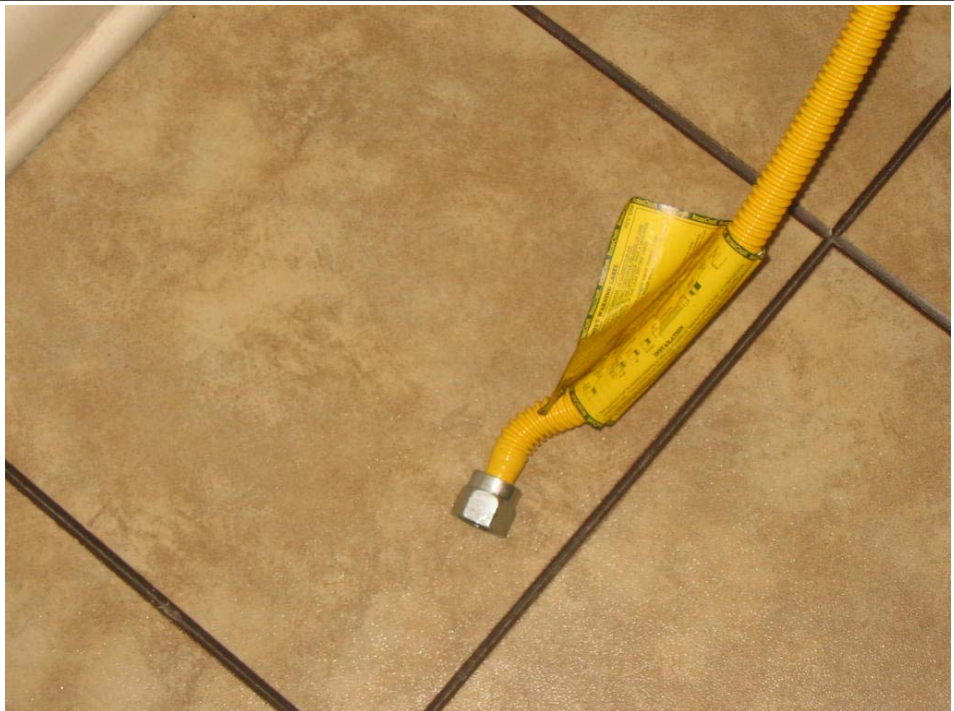
There is a unused gas line that is not capped. To prevent possible gas leakage, install a cap over the non used gas line.

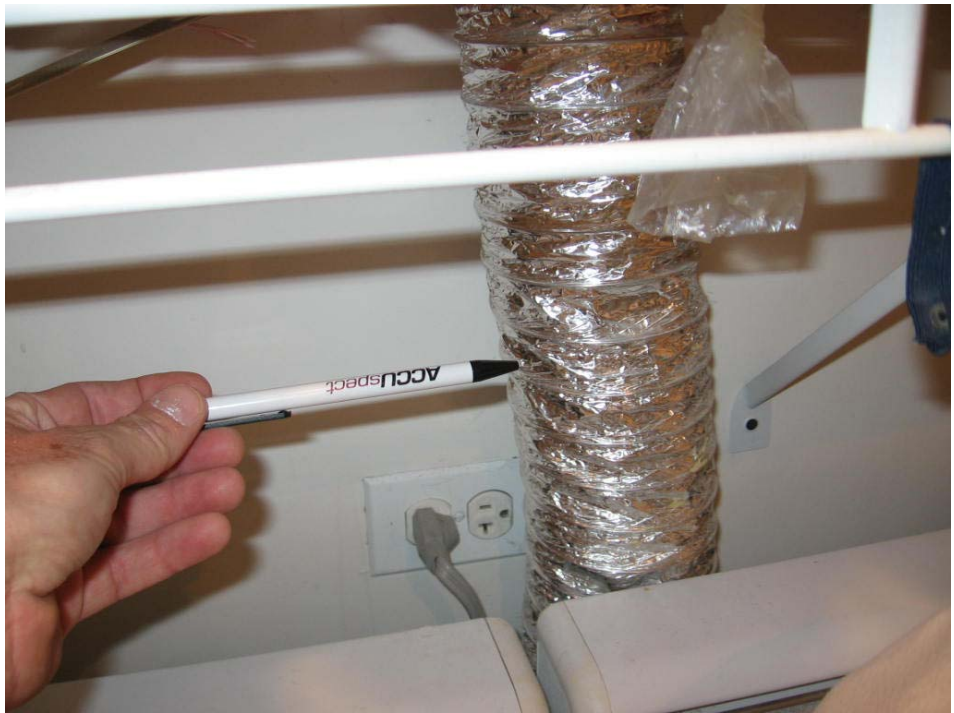
There was a foil accordion type dryer ducting material noted. Most manufacturers require the use of rigid or corrugated semi-rigid metal duct which provides maximum airflow. The flexible foil type duct can more easily trap lint and is more susceptible to kinks or crushing, which can greatly reduce the airflow. This reduced airflow can lead to heat build up and lint fires. Properly install the correct type of dryer connector as necessary.

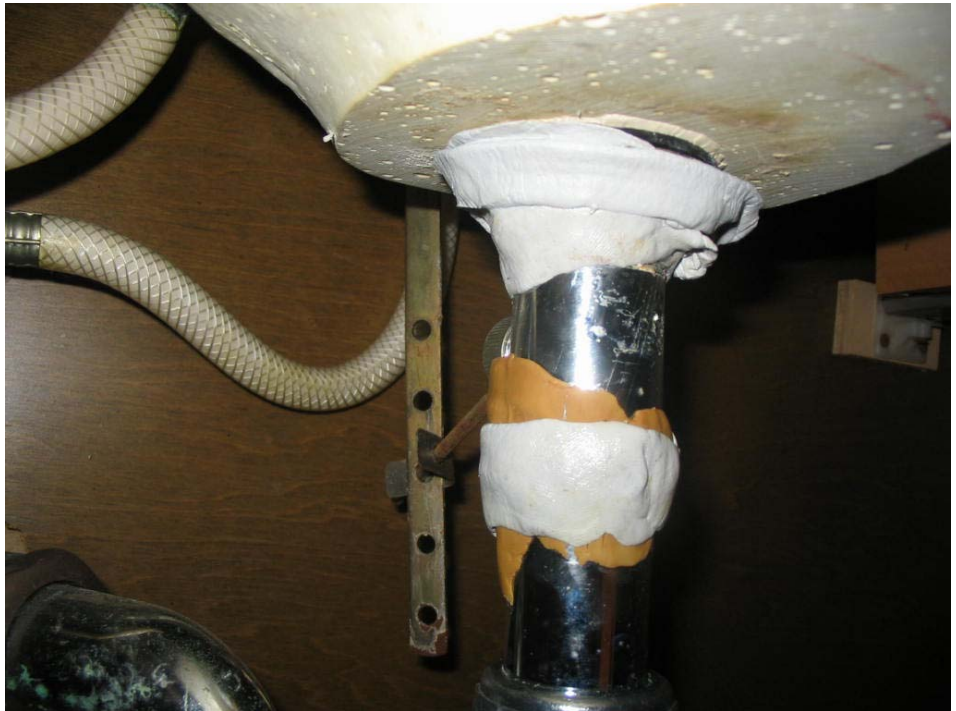
Parts of the drain line were taped or caulked up. There is no current leaking noted. This is not the proper type of repair. Replace effected sections of the drain pipe.

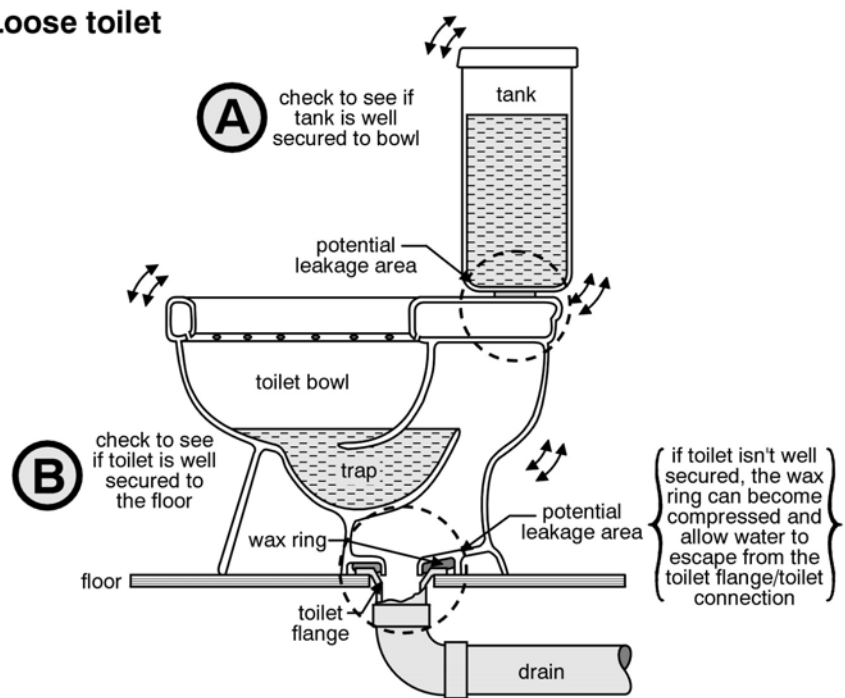
Loose toilet

The toilet was loose at the floor, however there is no current stains/leaks noted. Tighten up the toilet flange.

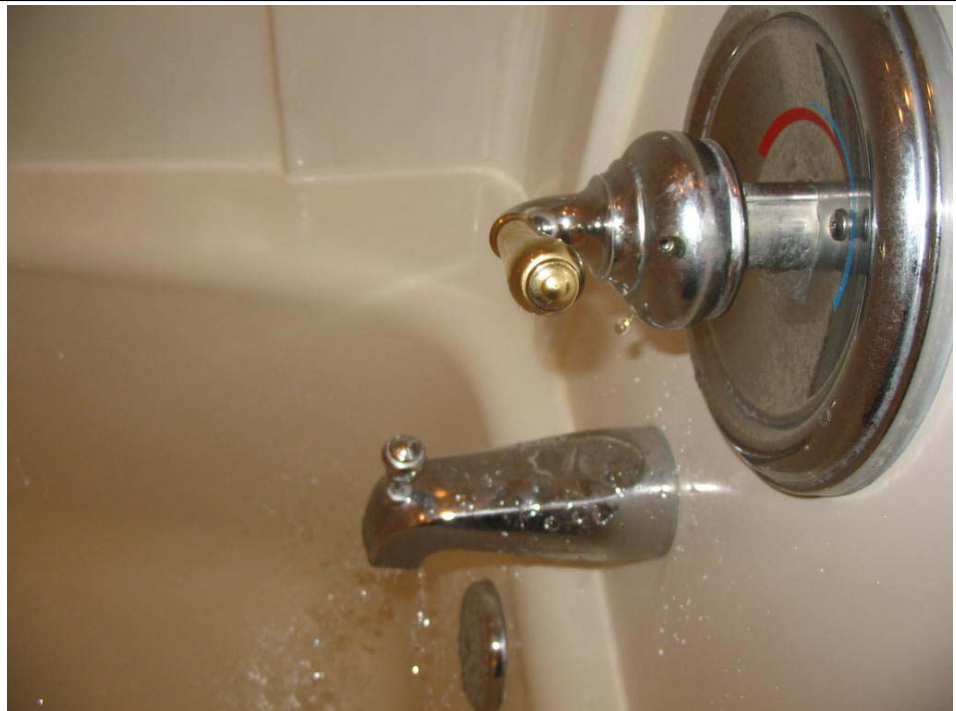
Minor leakage is noted at faucet handles. Repair/replace the faucets. The shower diverter is leaking. Replace the diverter.

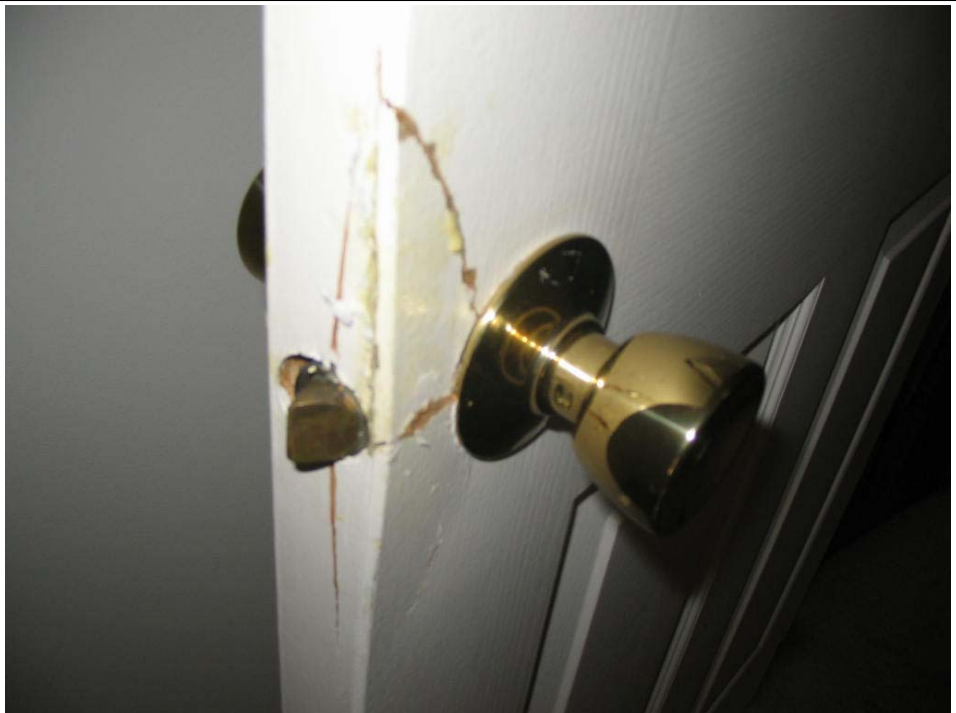
Damage noted. Repair/replace bedroom door as necessary.

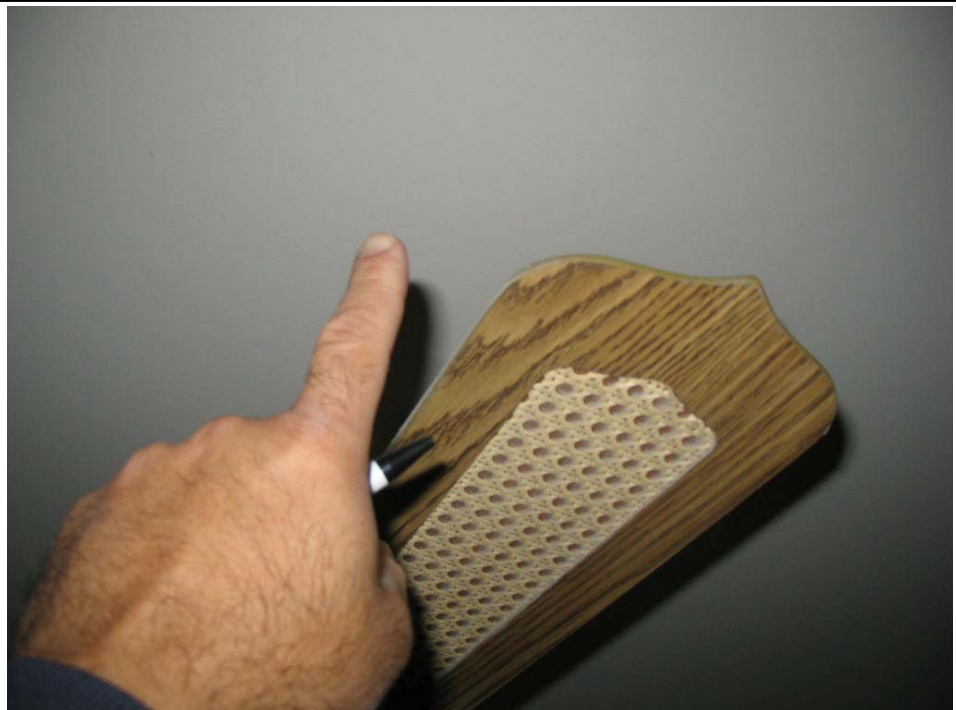
The ceiling fan(s) were too low. This poses a potential safety concern. Recommend removal.

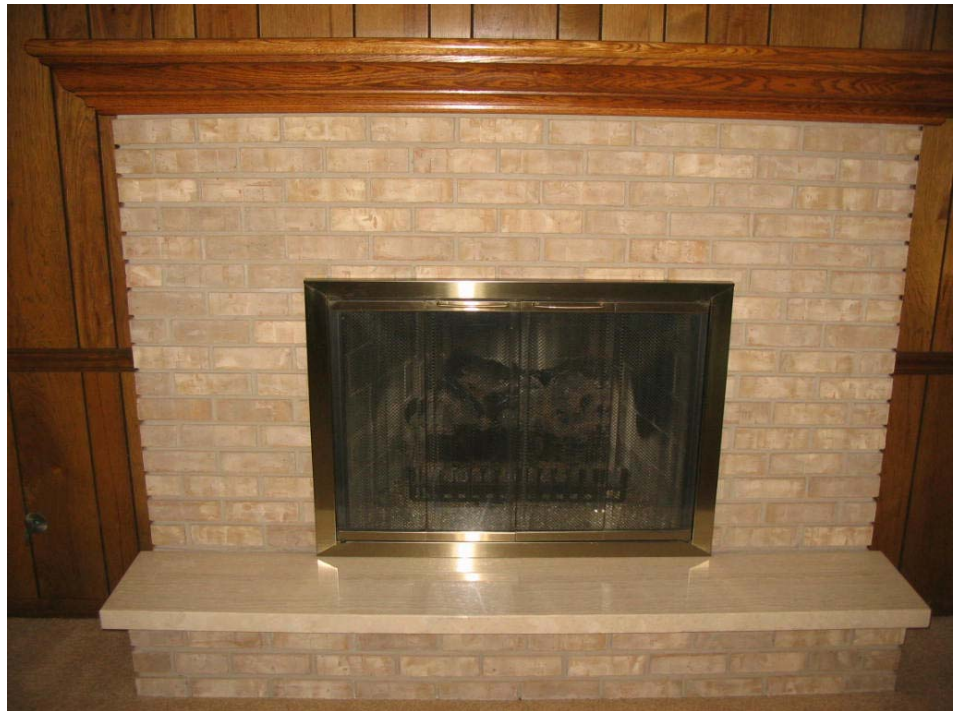
PICTURE:

On gas fireplaces where carbon monoxide levels may buildup, it is recommended to partially wire open the flue damper. Modify the flue damper. The gas log is burning dirty due to insufficient air flow. Clean if necessary, and adjust logs to allow for more air flow for proper/clean combustion.

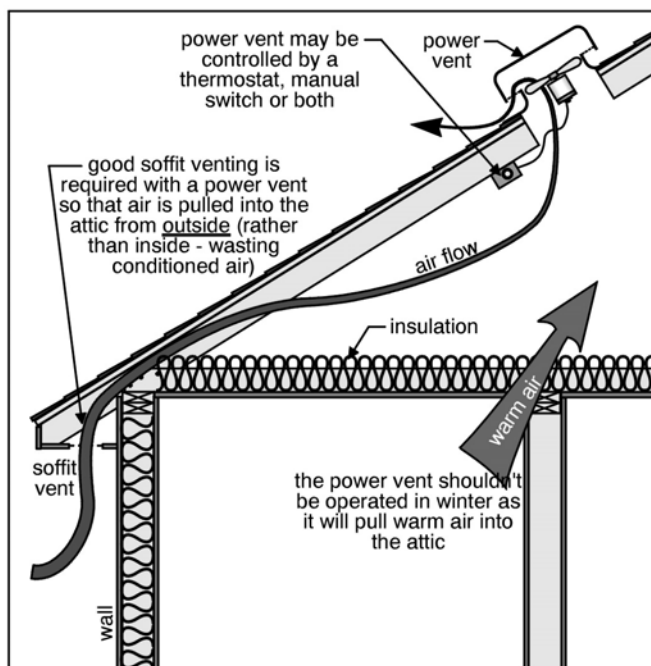
There is a power vent installed, due to low attic temperature/non adjustable thermostat, unable to test.

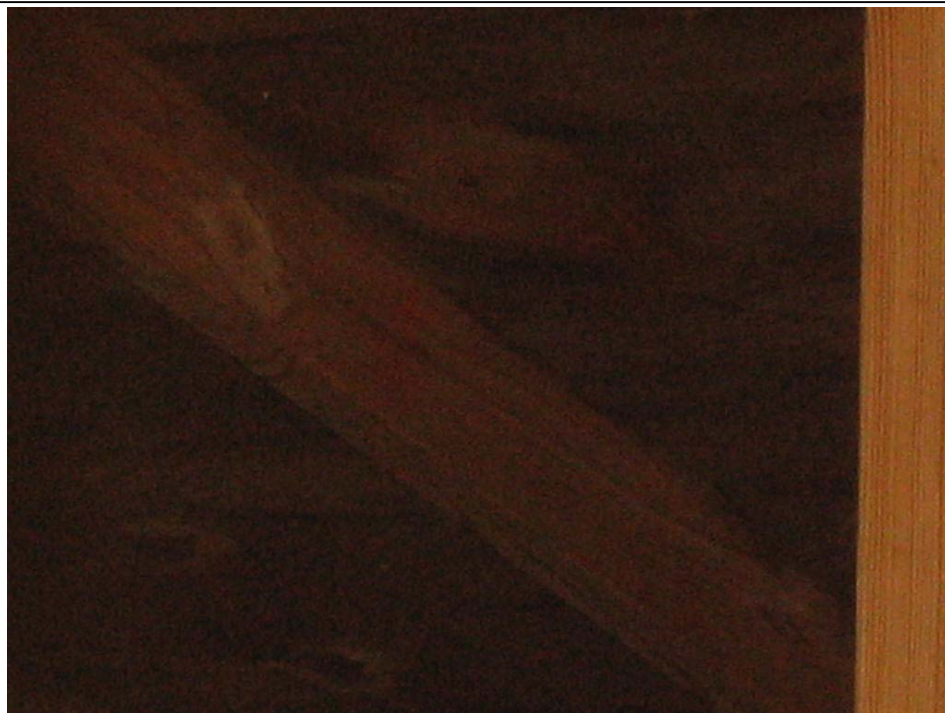
There appears to be areas that exhibit mold like staining. Unable to determine without laboratory analysis. Recommend further evaluation/remediation by a specialist (industrial hygienist)
