INSPECTION CONDITIONS

2626 N. XXXX Pl.

Accuspect

Home Inspection Services, Inc.

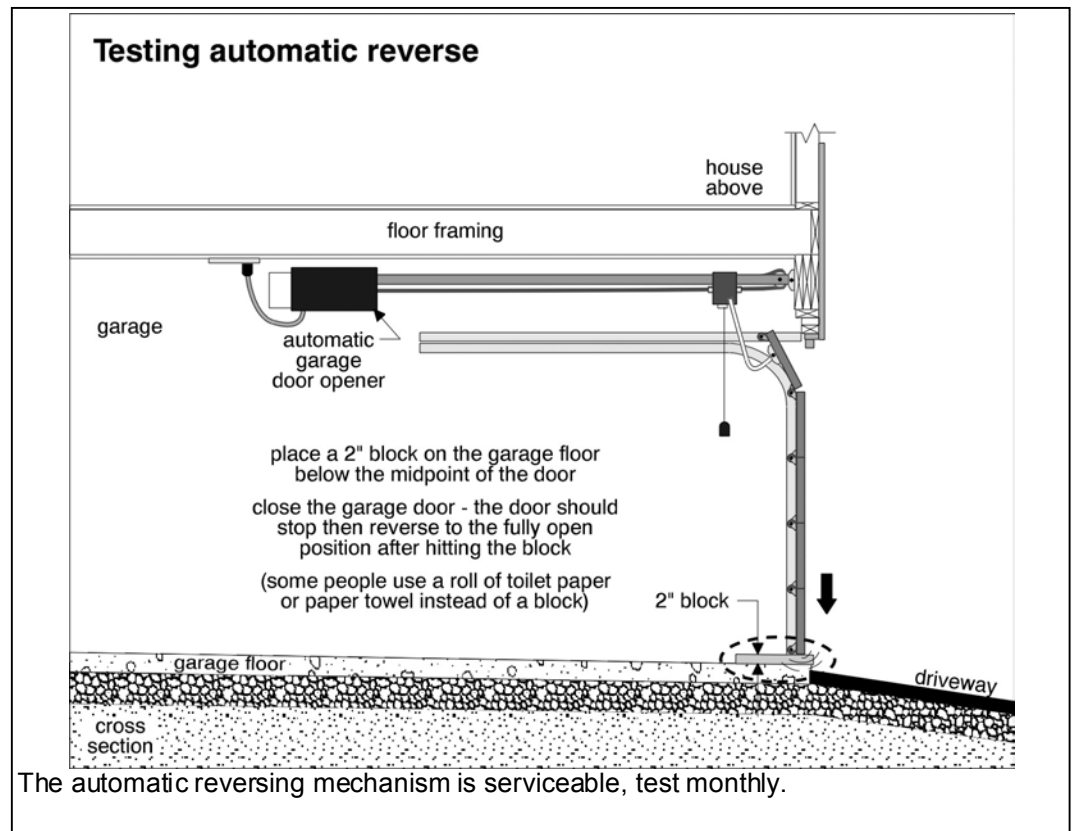
There was no garage door safety sticker installed. Recommend installing a safety sticker as necessary.

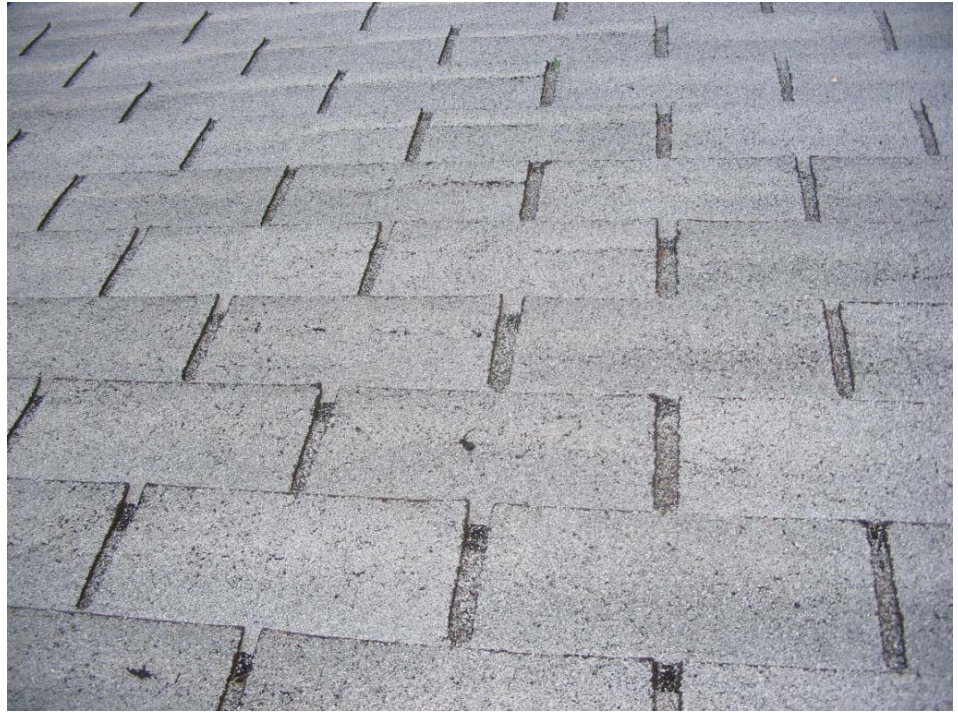
Cracking and clawing of shingles are the result of long term weathering and an advanced shingle age. There was also excessive granular wear noted. The roof appears to have two layers of shingles installed. Anticipate the need to replace the roof covering in the not too distant future.

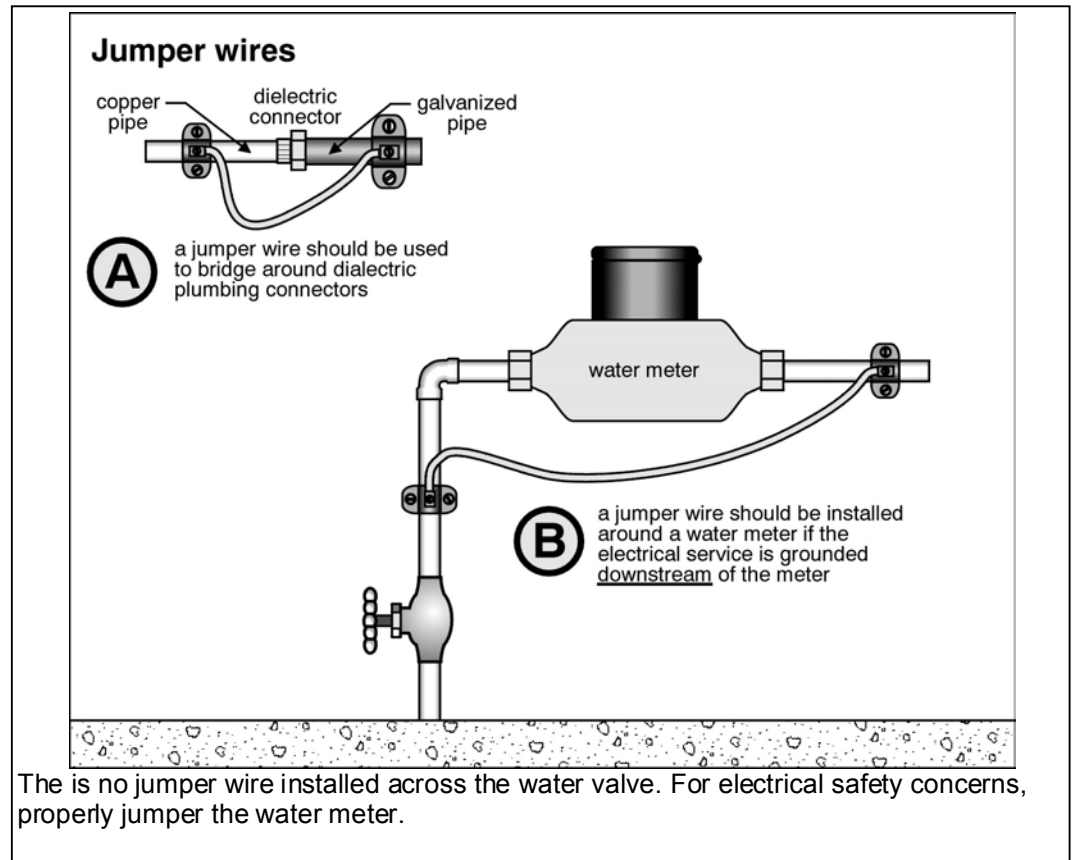
There was no Do Not Remove tag noted to the grounding connector. Install as necessary.

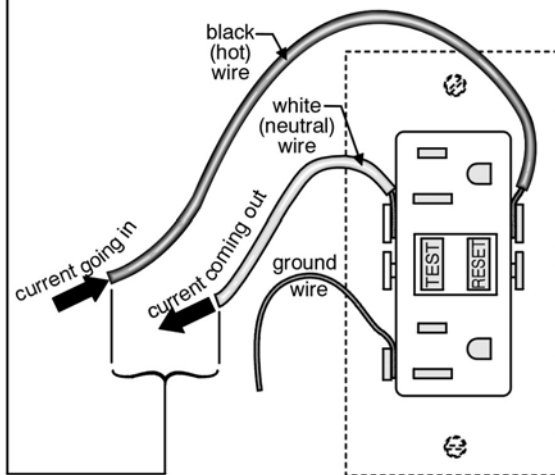
There was no GFI's noted. It is a good safety practice to install GFI's at the exterior, garage, bathroom, and within 6 feet of a kitchen sink. Recommend installing GFI's in the appropriate locations.

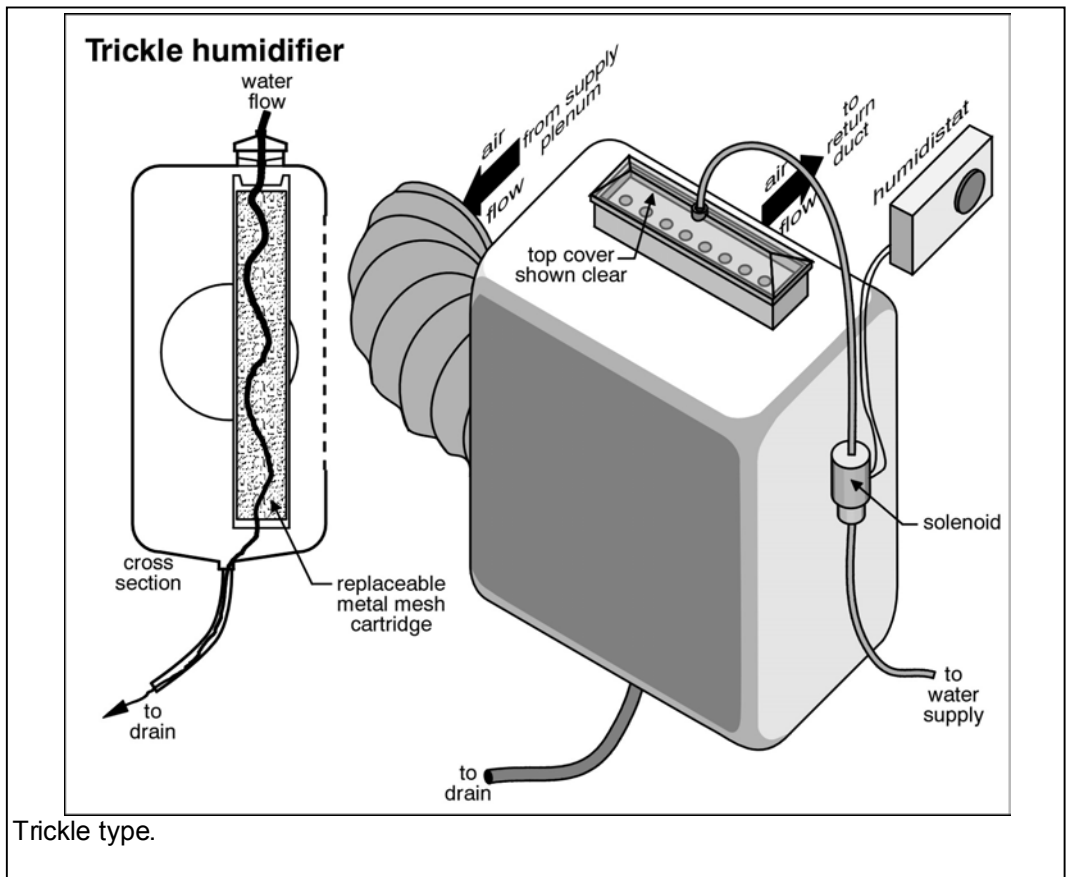
The humidifier pad is dirty. Clean the unit, and replace pad.

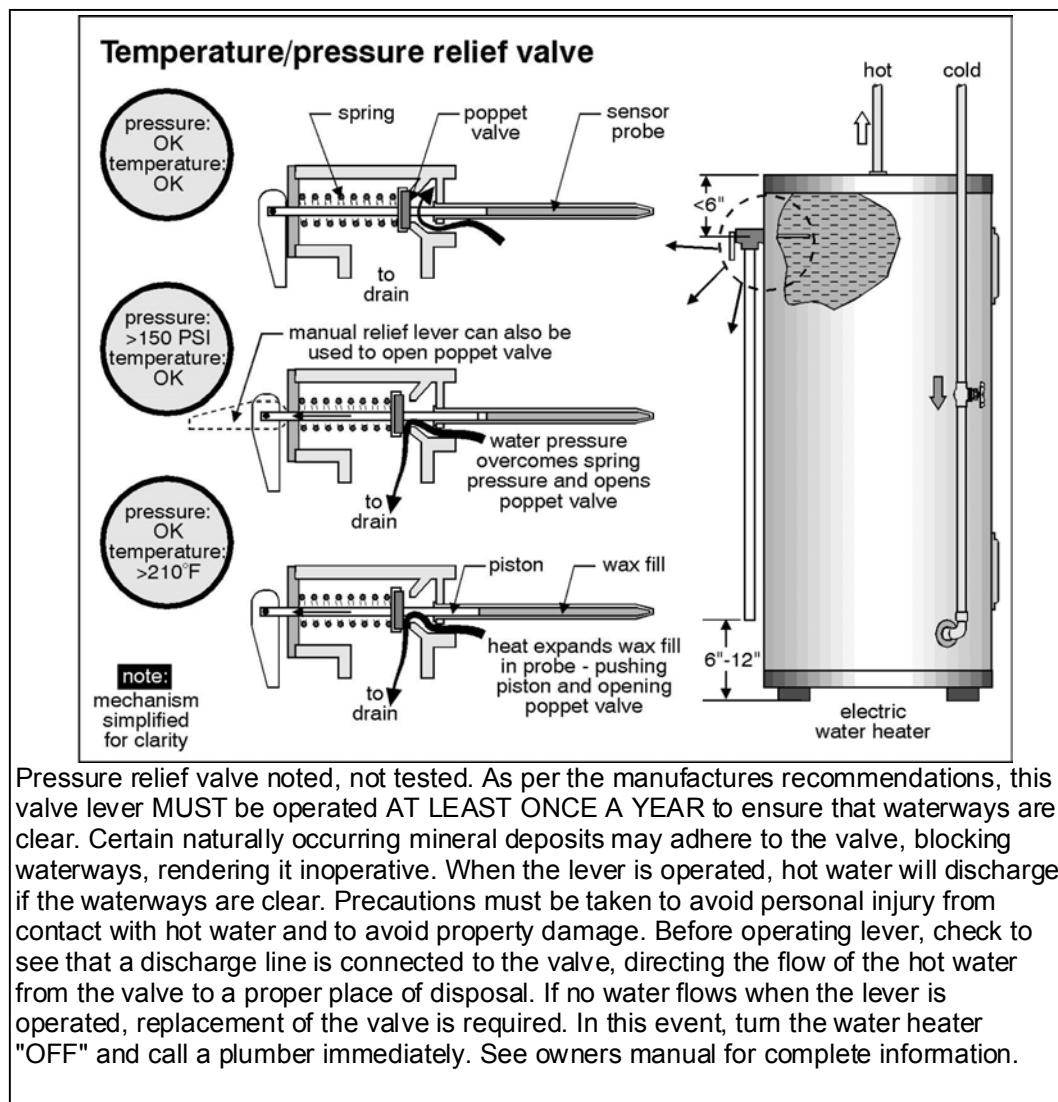
Pressure relief valve noted, not tested. As per the manufactures recommendations, this valve lever MUST be operated AT LEAST ONCE A YEAR to ensure that waterways are clear. Certain naturally occurring mineral deposits may adhere to the valve, blocking waterways, rendering it inoperative. When the lever is operated, hot water will discharge if the waterways are clear. Precautions must be taken to avoid personal injury from contact with hot water and to avoid property damage. Before operating lever, check to see that a discharge line is connected to the valve, directing the flow of the hot water from the valve to a proper place of disposal. If no water flows when the lever is operated, replacement of the valve is required. In this event, turn the water heater "OFF" and call a plumber immediately. See owners manual for complete information.

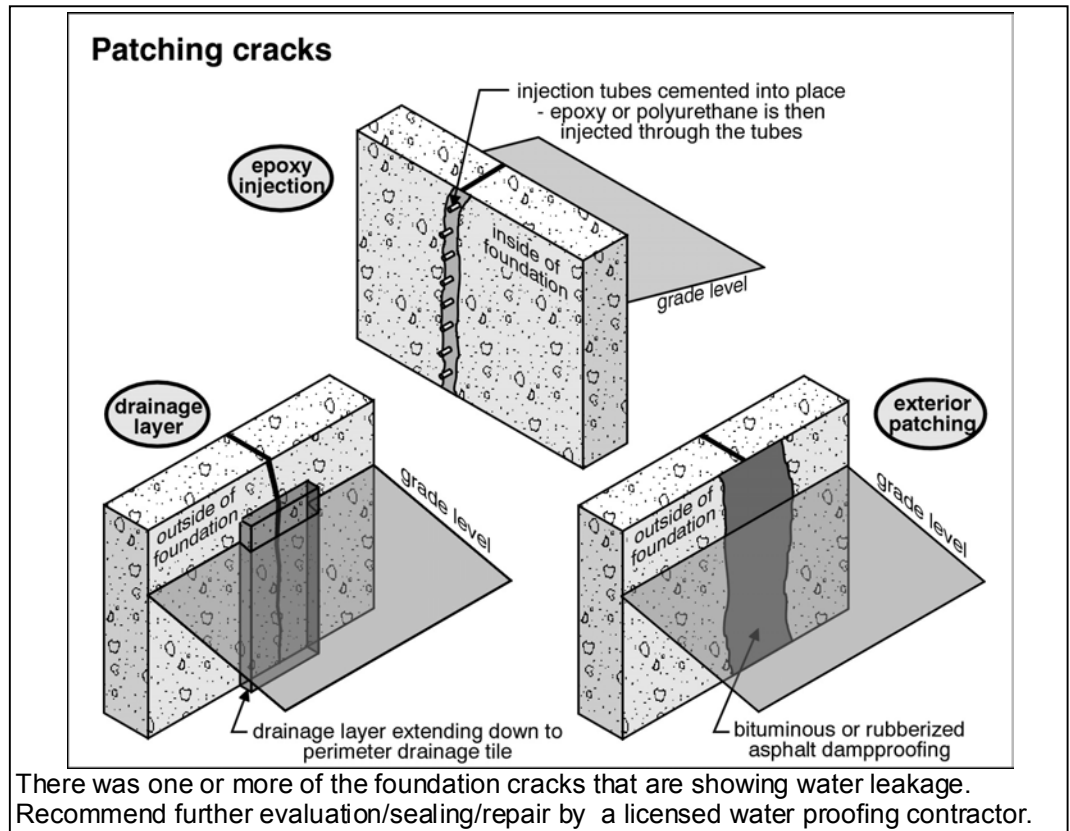
There are one or more patched foundation cracks noted. No present signs of water leakage past the cracks. Appears serviceable.

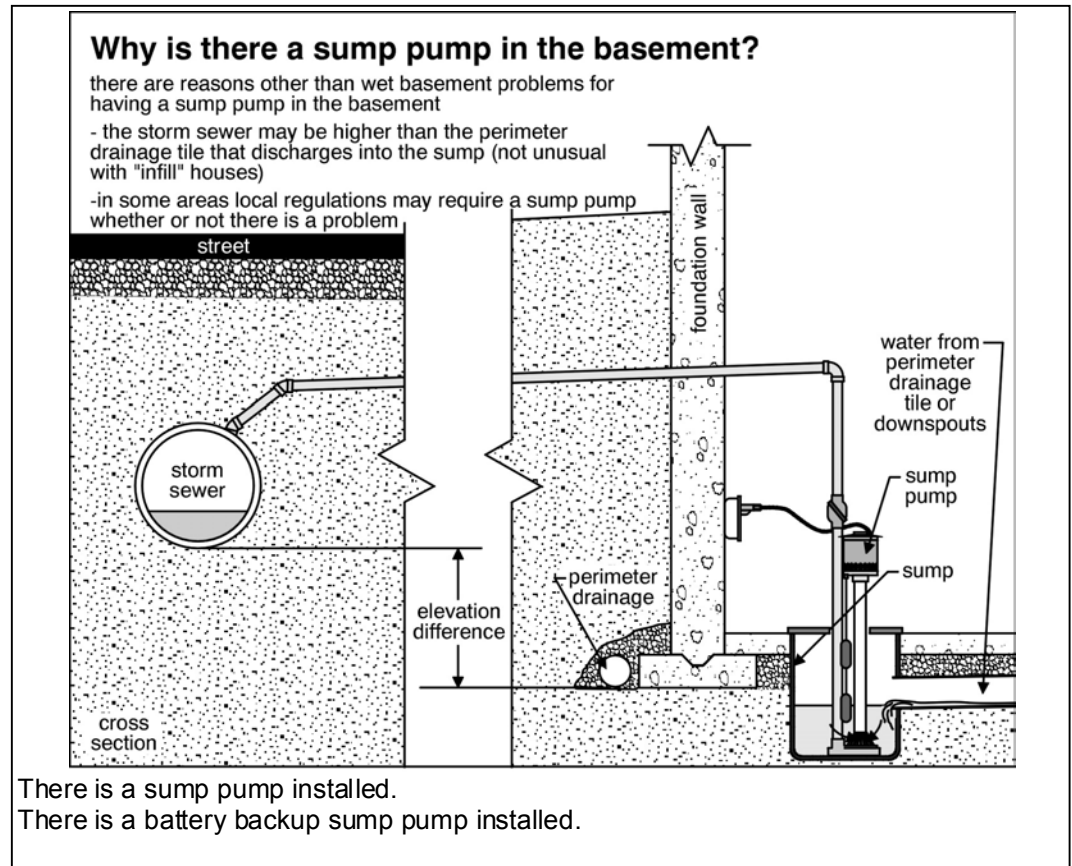
The sump pump was operationable. The check valve appears serviceable.

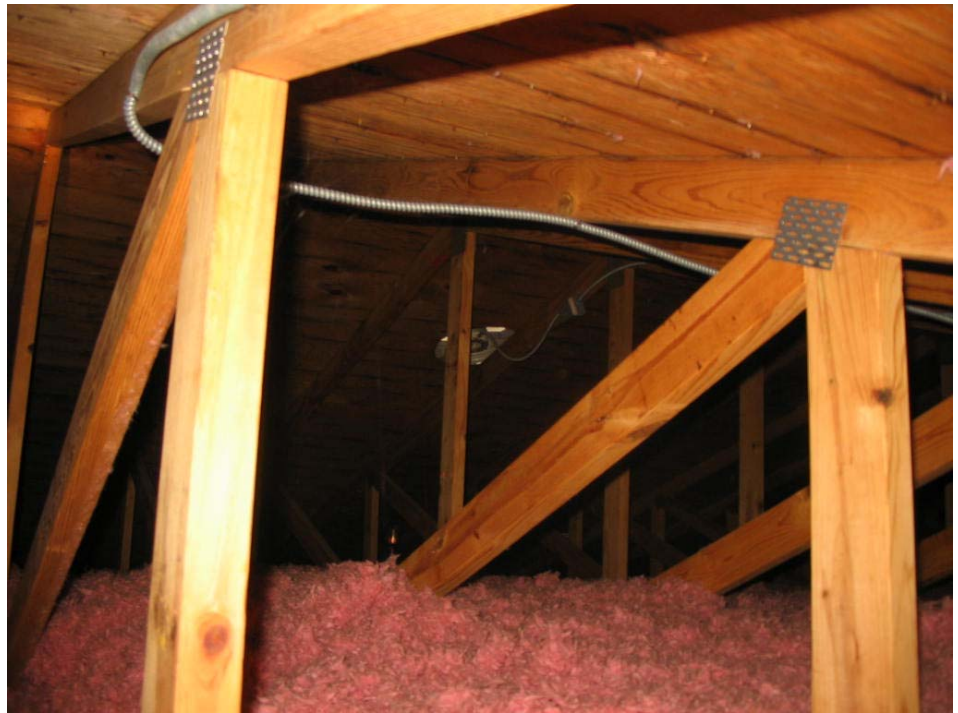
PICTURE OF ATTIC:

There was limited access to the attic due to no walk boards. Unable to walk into the attic via low clearance height. Viewed the attic from the access hatch. Limited inspection. Due to limited access, the attic was viewed from the access hatch via a ladder. Limited inspection.
